SUBJECT: Recommendations and HRS considerations for the **Big River Mine**
Tailing site in Desloge, Missouri
TDD #F-07-8711-039 PAN #FM00616PA
Site #Y60 Project #001
Superfund Contact: Gene Gunn

Preliminary Assessment
Big River Mine Tailings
Desloge, St. Francois County, Missouri
TDD #F-07-8711-039 PAN #FM00616PA
Site #Y60 Project #001
Submitted to: Paul E. Doherty, RPO
Task Leader: Robert Overfelt, E & E/FIT
Superfund Contact: Gene Gunn
Date: May 17, 1988

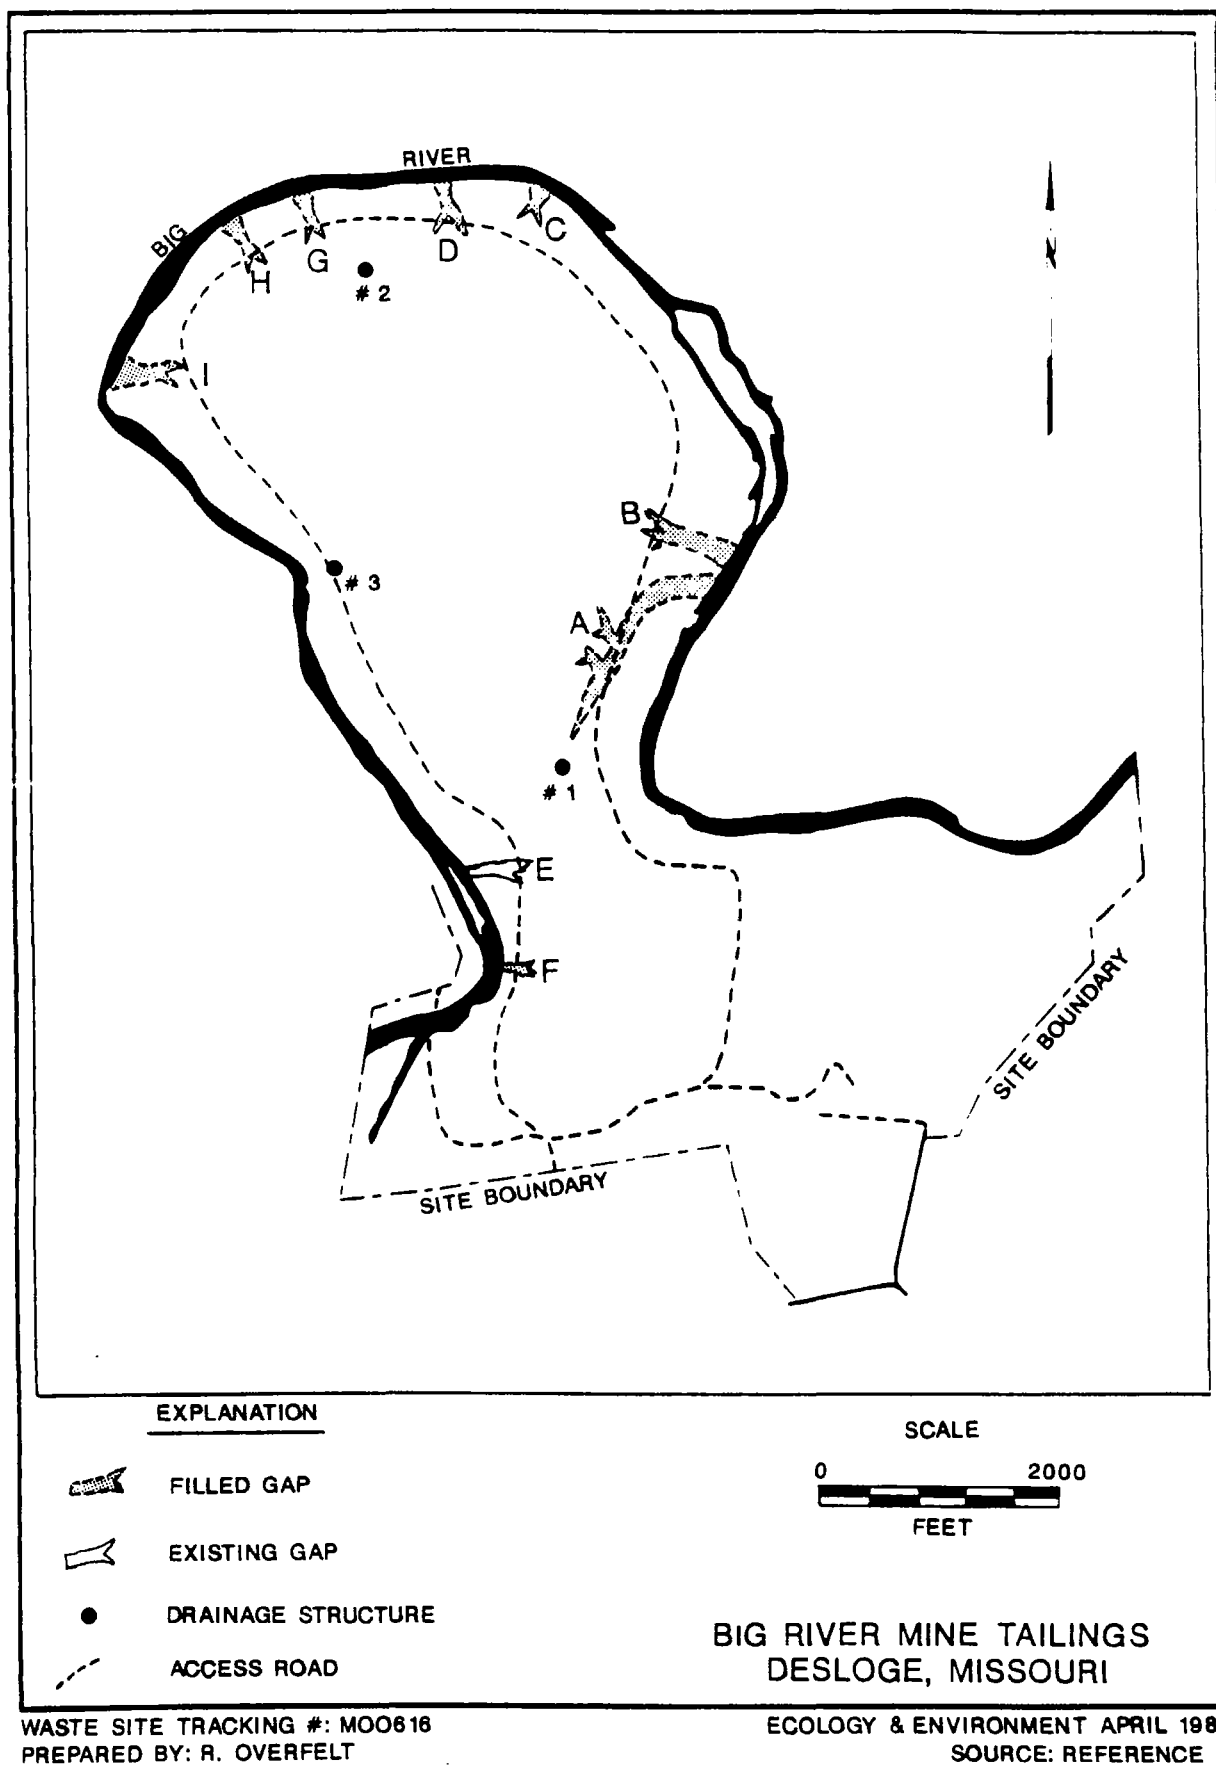
FIGURE 3: MAJOR EROSIONAL FEATURES

The original drainage structures placed by the mining company are illustrated in Photo C-14 (Appendix D). These concrete drainage structures were constructed to drain the water from off the tailings pile. During the E & E/FIT site reconnaissance, it was noted that drainage structure #1 near Gap A was totally collapsed and was no longer functional. According to the UMC report, drainage structure #1 became blocked and this blockage led to the massive erosion which occurred in 1977 at Gaps A and B. The UMC report recommended that the major erosional gaps be filled with a suitable fill material and the area reshaped to reduce further erosion. Further, the report suggested that the drainage structure located near Gap A be altered to minimize the chance for overflow (Ref. 4).

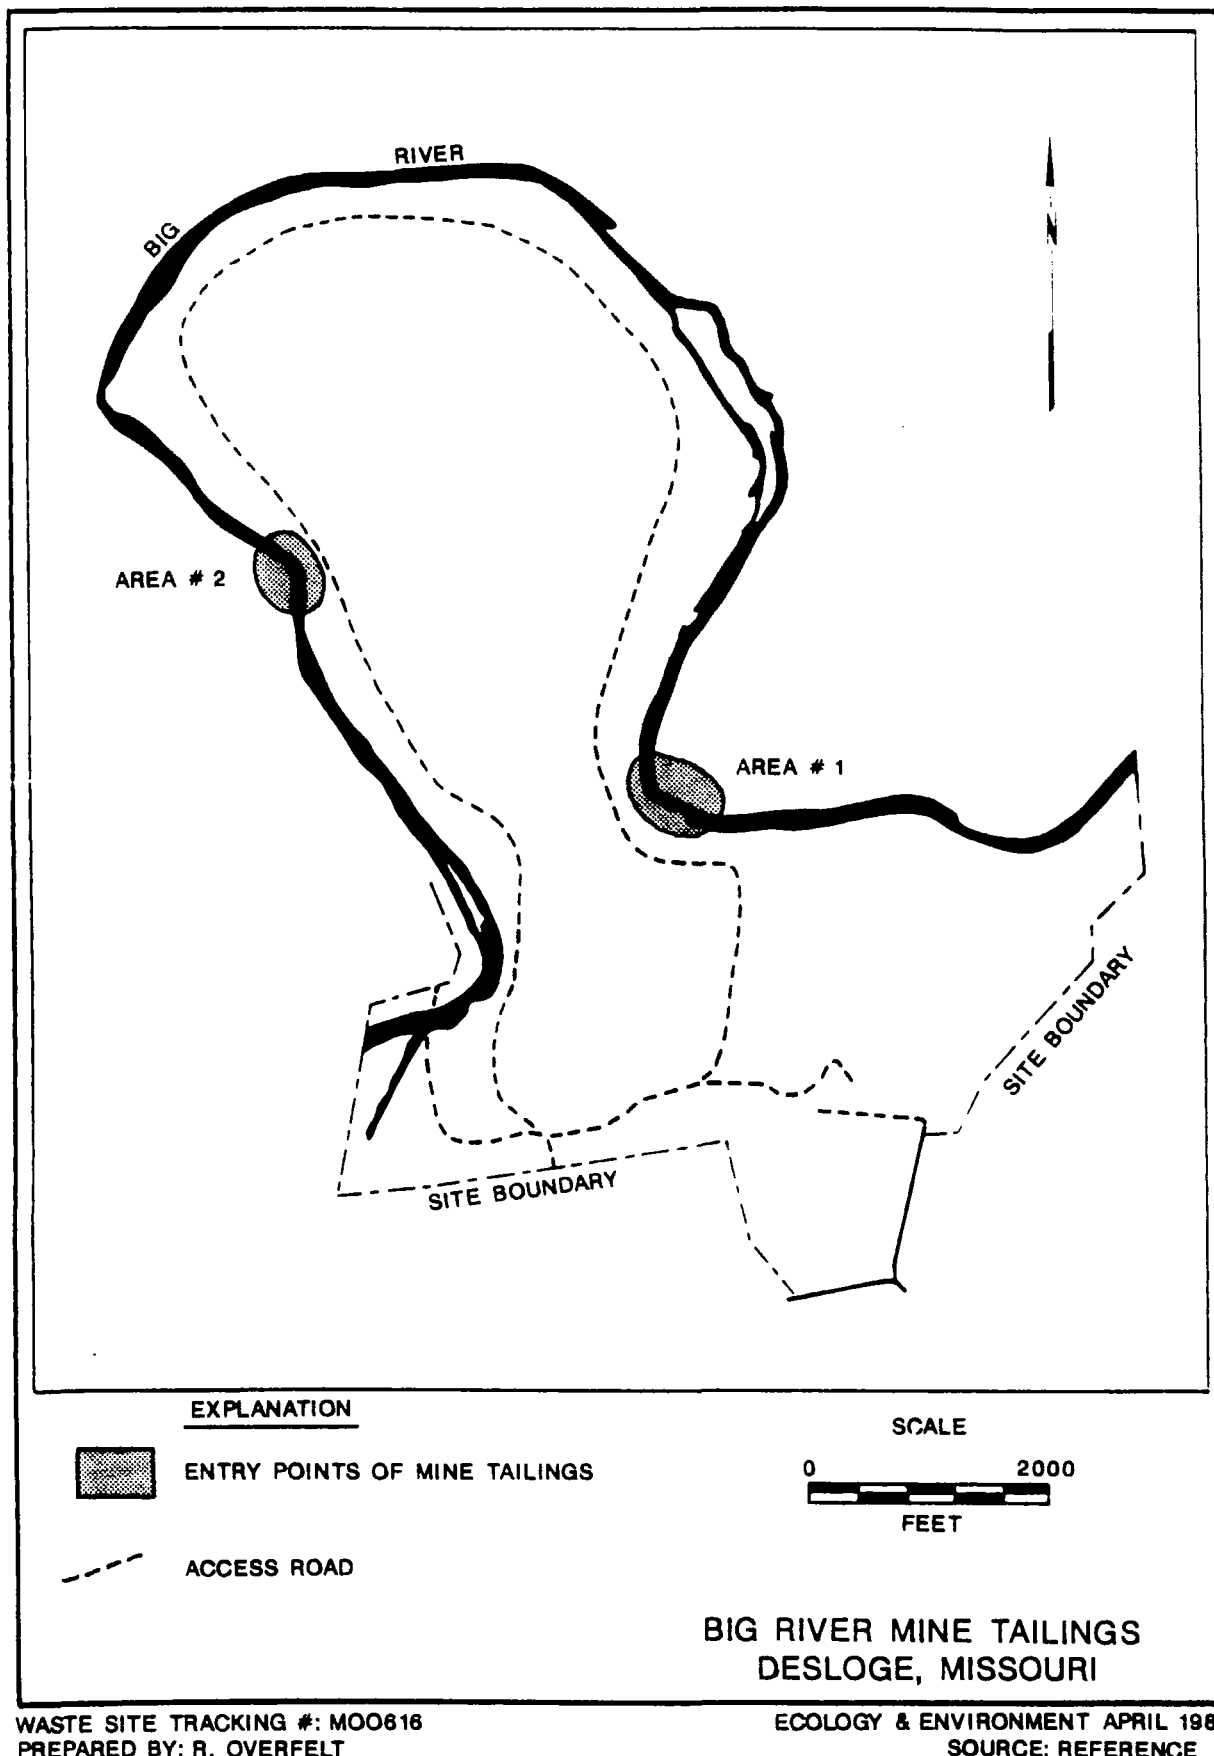
FIGURE 4: OBSERVED ENTRY POINTS OF MINE TAILINGS TO BIG RIVER

Wind erosion and the associated blowing of lead-laden dust is also a major concern (Appendix D, Photo C-1). There the tailings pile reaches the river bank in two areas (Figure 4). During the FIT reconnaissance, it was noted areas #1 and #2 that the wind was eroding the tailings over the steep incline. As tailings accumulate, and their angle of repose is exceeded, they collapse and fall into the river (Photo C-2). The major problem at area #2 is the river undercutting the bank, which eventually could lead to a collapse of the tailings in the area into the river (Photos C-12, C-13). Wind erosion is generally from west to east, which produces a continuous movement of the tailings toward the east. Because the tailings are a very fine, dolomitic sand or silt sufficient wind velocity creates a tailings dust cloud. During the site reconnaissance this occurrence was observed to be a serious problem (Photo C-1). A dust plume originating from the site was transporting dust at least one mile to the southeast. Wind speeds on that day included gusts up to 35 miles per hour.
